Debris/Ice/TPS Assessment and Integrated Photographic Analysis of Shuttle Mission STS-72

**DEBRIS/ICE/TPS ASSESSMENT
AND
INTEGRATED PHOTOGRAPHIC ANALYSIS
OF
SHUTTLE MISSION STS-72**

11 January 1996

**NASA, Lockheed-Martin, Rockwell, and Thiokol Members of the
Debris/Ice/TPS and Photographic Analysis Teams**

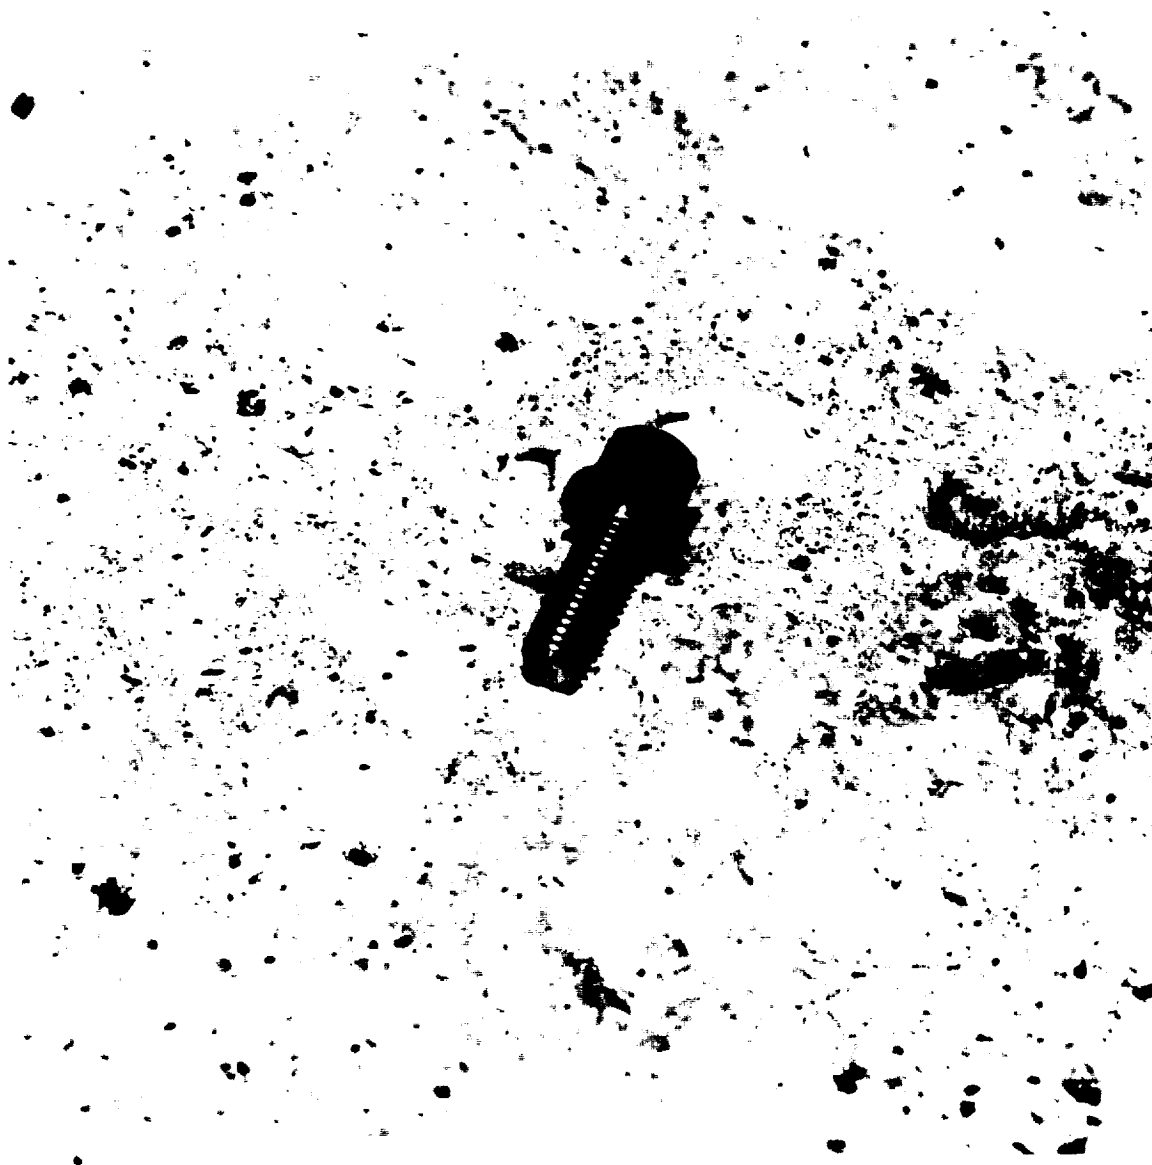
Photo 24: Debris Found on Runway Under Umbilical Cavity

The only debris found on the runway under the umbilical cavities (LH2) consisted of a bolt 0.875-inches long by 0.1875-inch diameter with a red coating on the bolt head. The bolt, which is stamped with the number MS 21279-7, is used in the Orbiter aft compartment SSME wire bundle clamps. A post flight inspection of the aft revealed no missing bolts (Ref. Lost and Found PR LAF-5-11-0199).

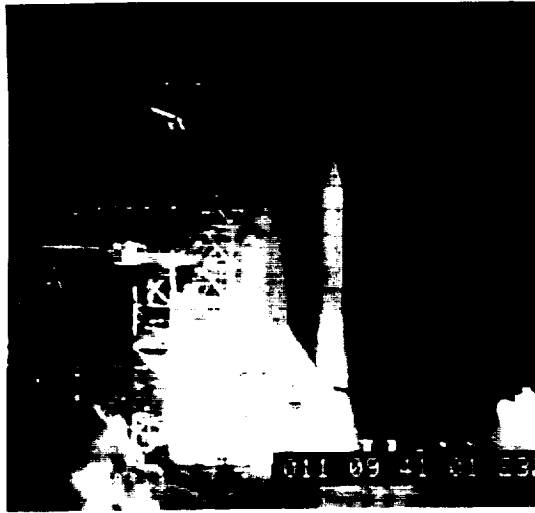
Figure 2.1.2.2 Flame Trench Debris

Several pieces of flame trench debris were seen north of the vehicle at SRB ignition (011:09:41:01.232 UTC). The debris moved north away from the vehicle and was not seen to strike the vehicle.

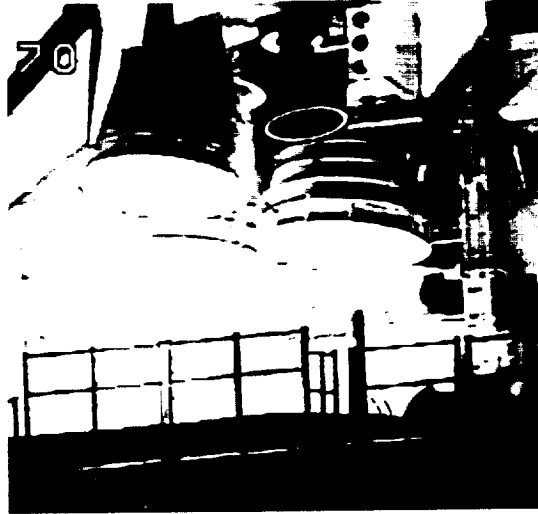
Figure 2.1.2.4 Debris Near Starboard RCS Stinger

A large, thin, rectangular piece of RCS paper fell from the starboard RCS stinger at liftoff (011:09:41:00.693 UTC).

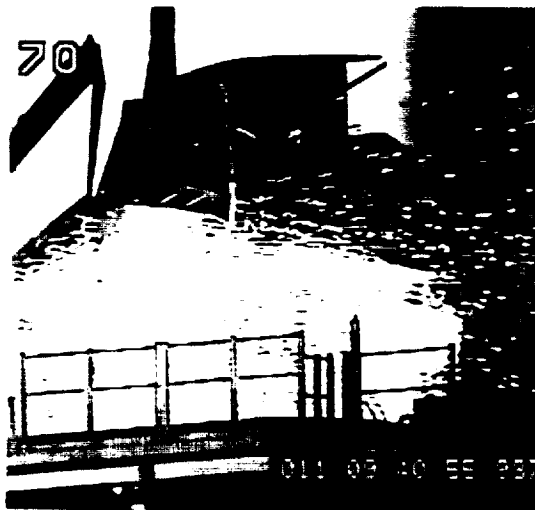
Figure 2.2.3 Orange Vapor

Orange vapor (possible free burning hydrogen) was seen above the SSME bells, by the port RCS stringer, under the bodyflap, near the vertical stabilizer and near the base heat shield during SSME ignition (09:40:54.2 UTC). Orange vapor has been seen on previous missions. No follow-up action was requested.
